Test Report

Model: Multi Joint Wrap  
Temperature: 25°C

Manufacture: 660nm+850nm  
Humidity: 60%  
Test Date: 2023-10-25,14:09:01

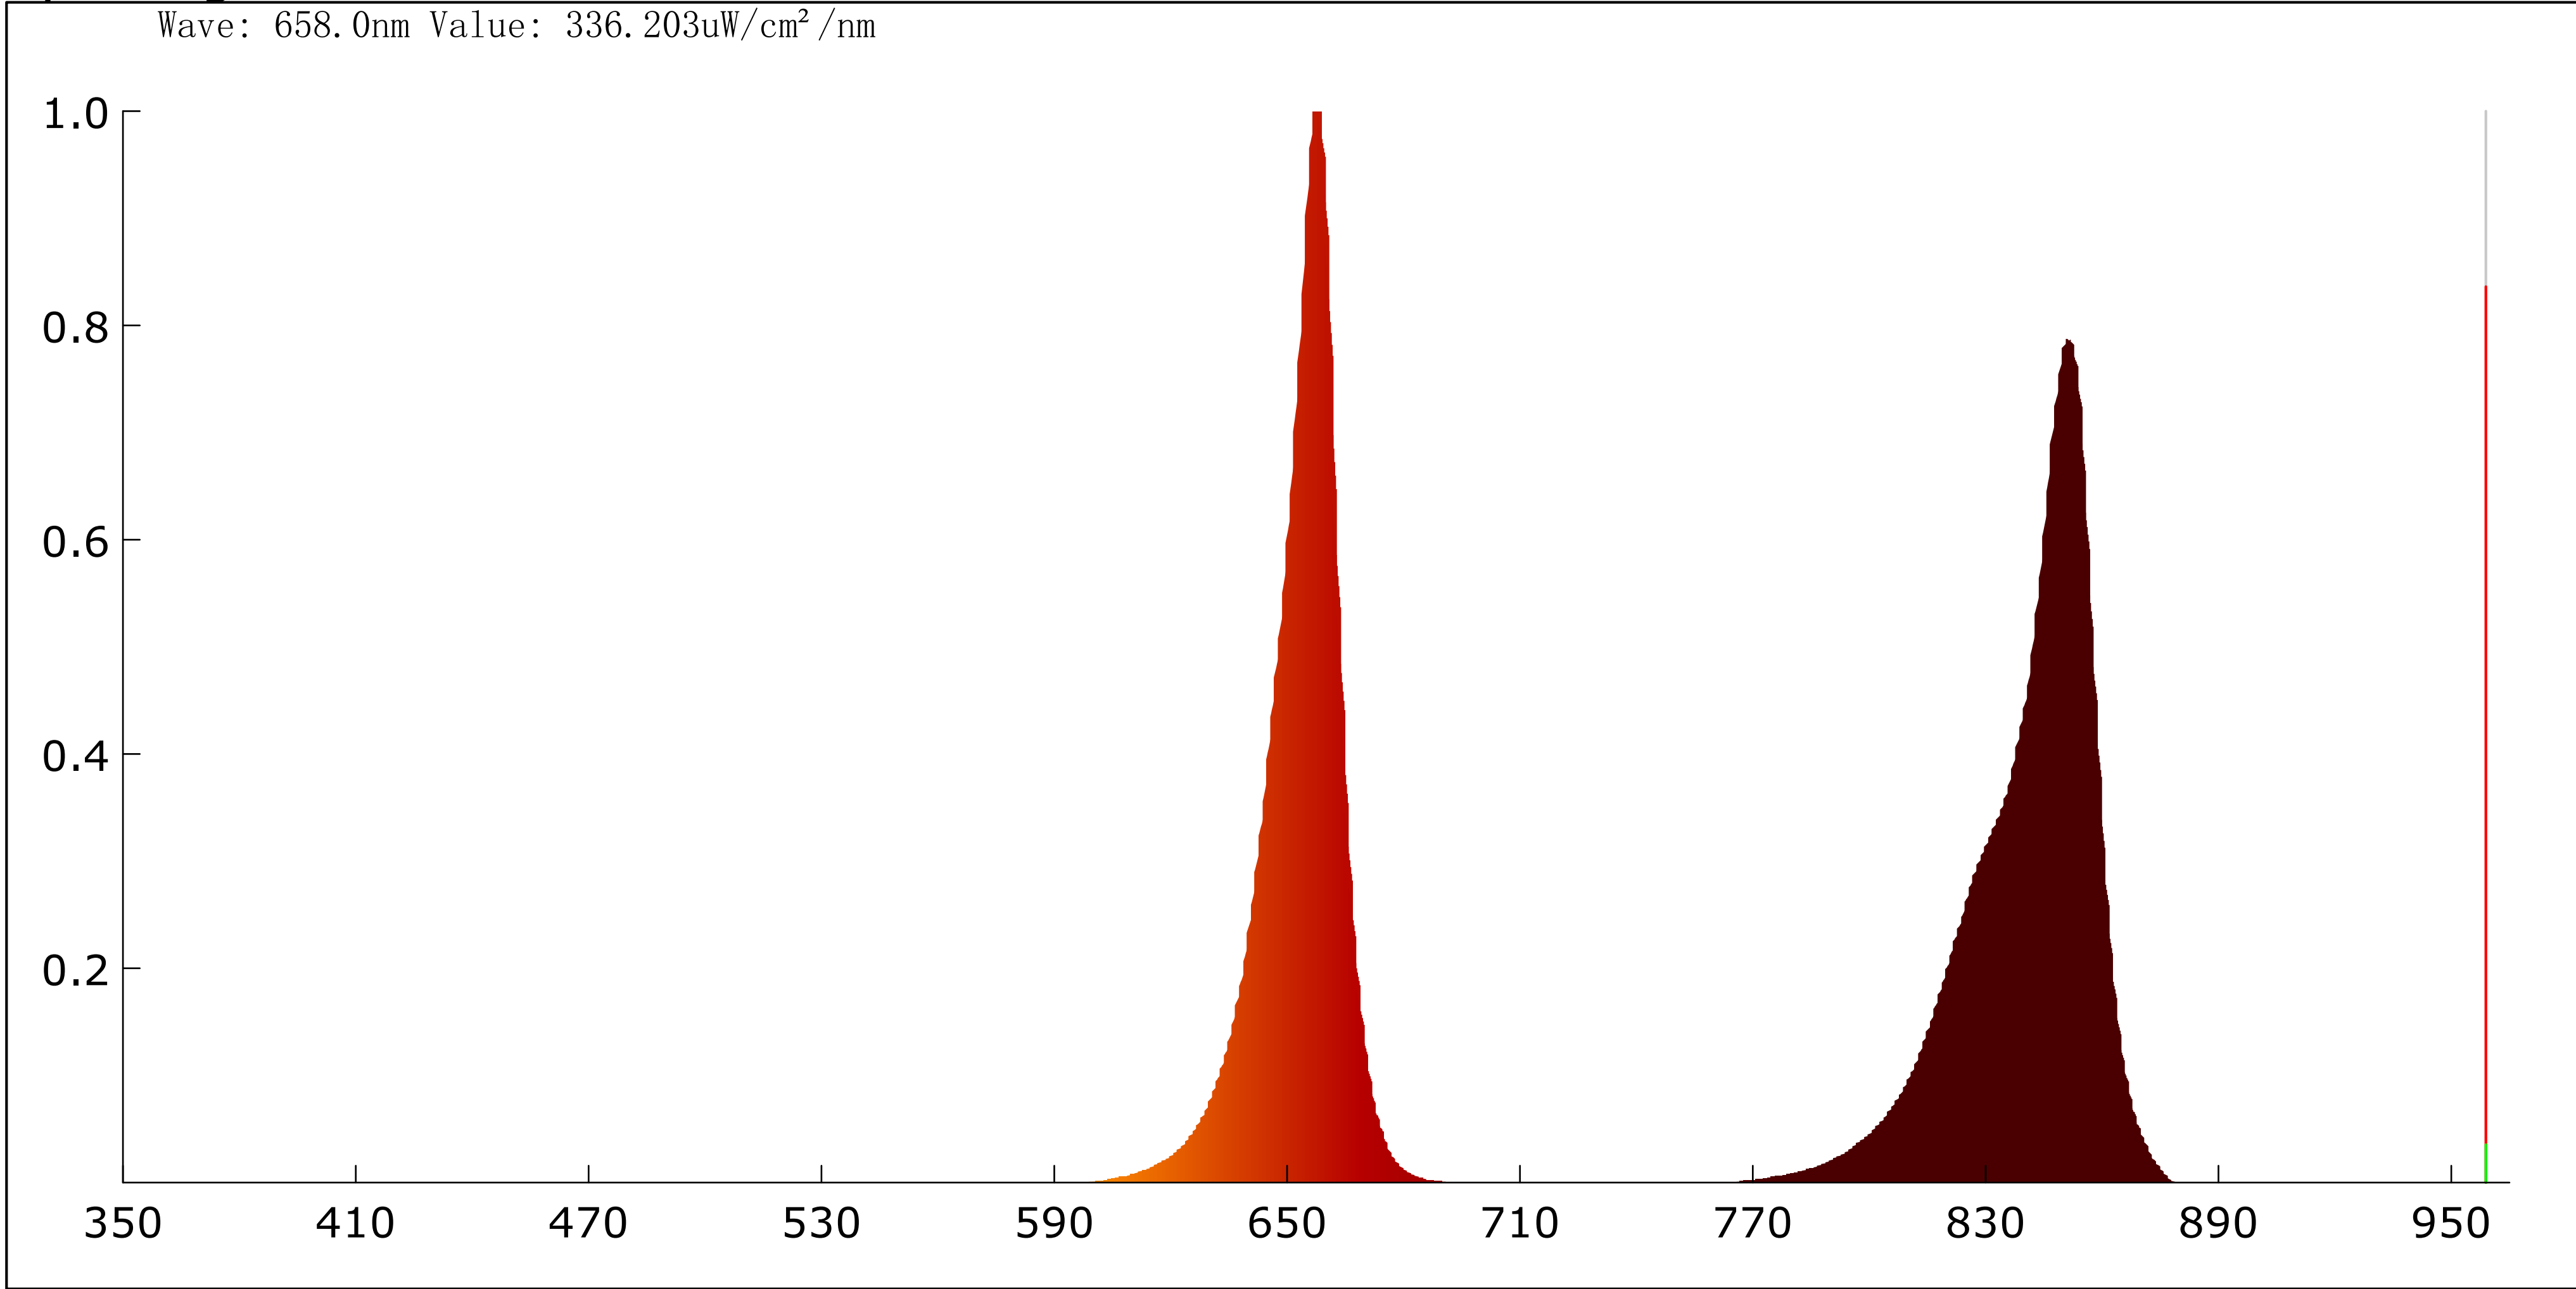
Spectrogram

| Name | Value | Name | Value | Name | Value | Name | Value |
|---|---|---|---|---|---|---|---|
| Peak(nm) | 658.8 | | | | | | |
| Center(nm) | 656.5 | | | | | | |

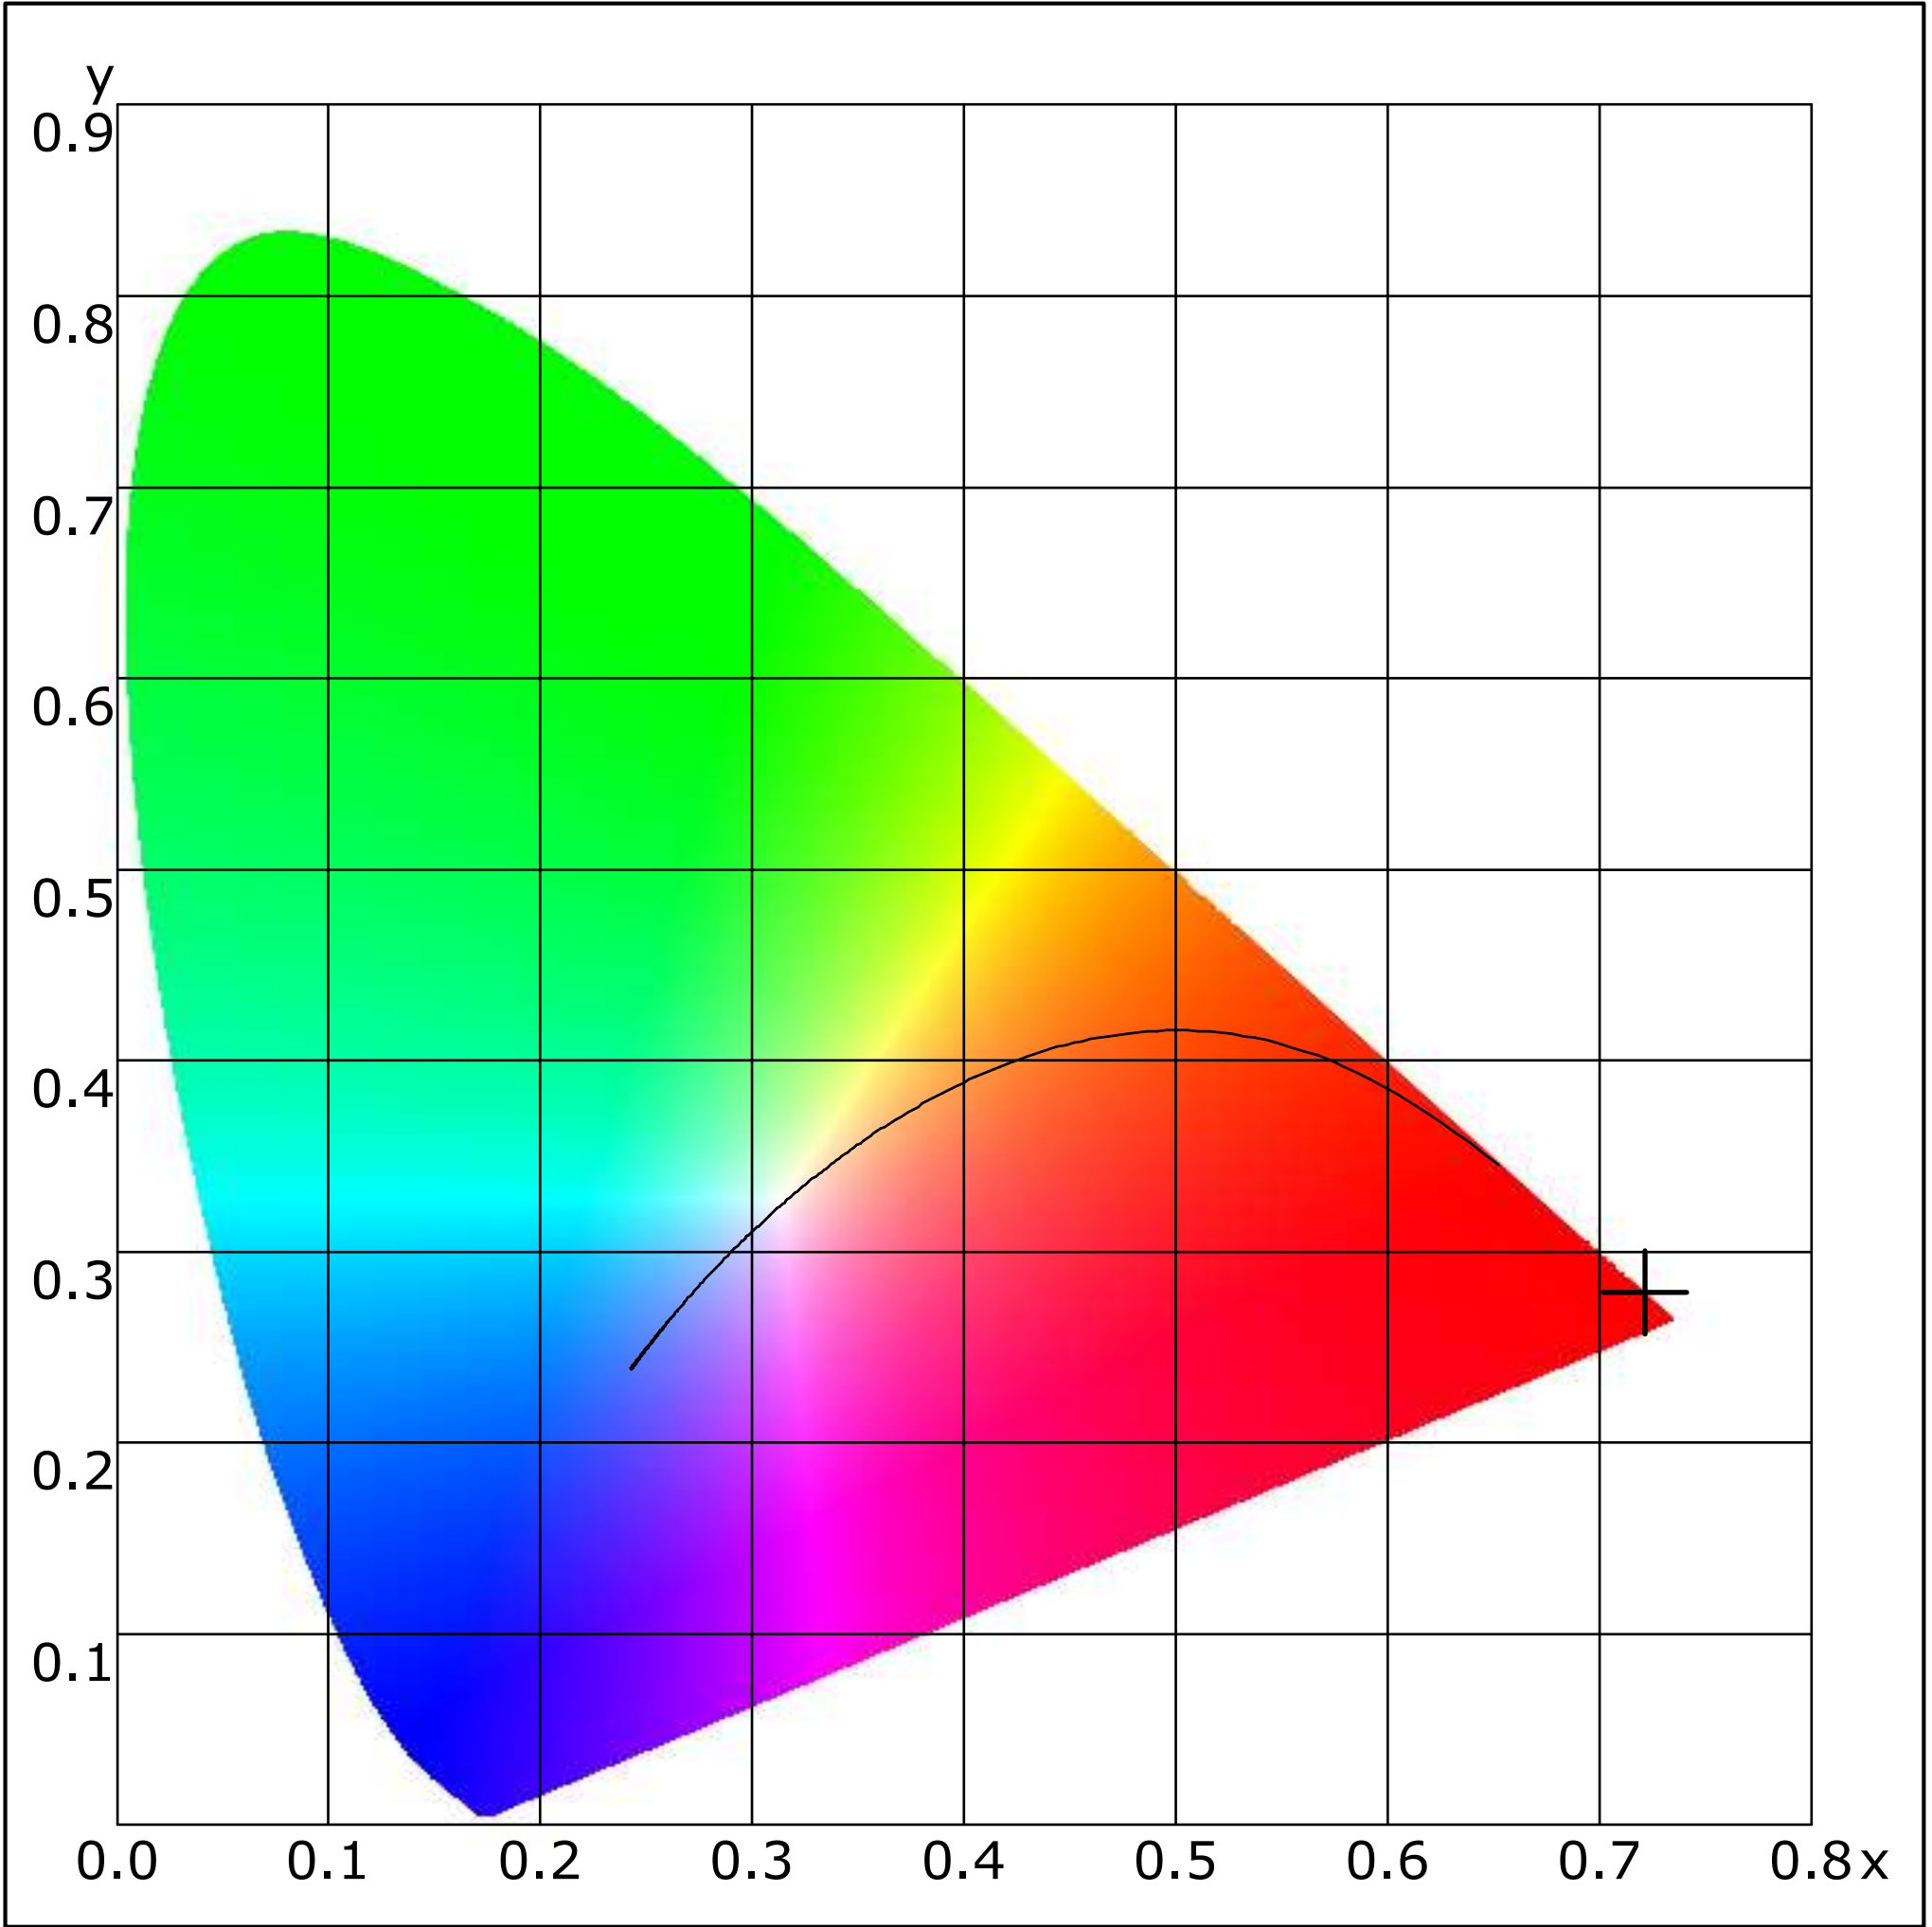
| Name | Value | Name | Value | Name | Value | Name | Value |
|---|---|---|---|---|---|---|---|
| CIE x,y | 0.7218,0.2782 | CIE1931 Z | 0.538 | | | | |

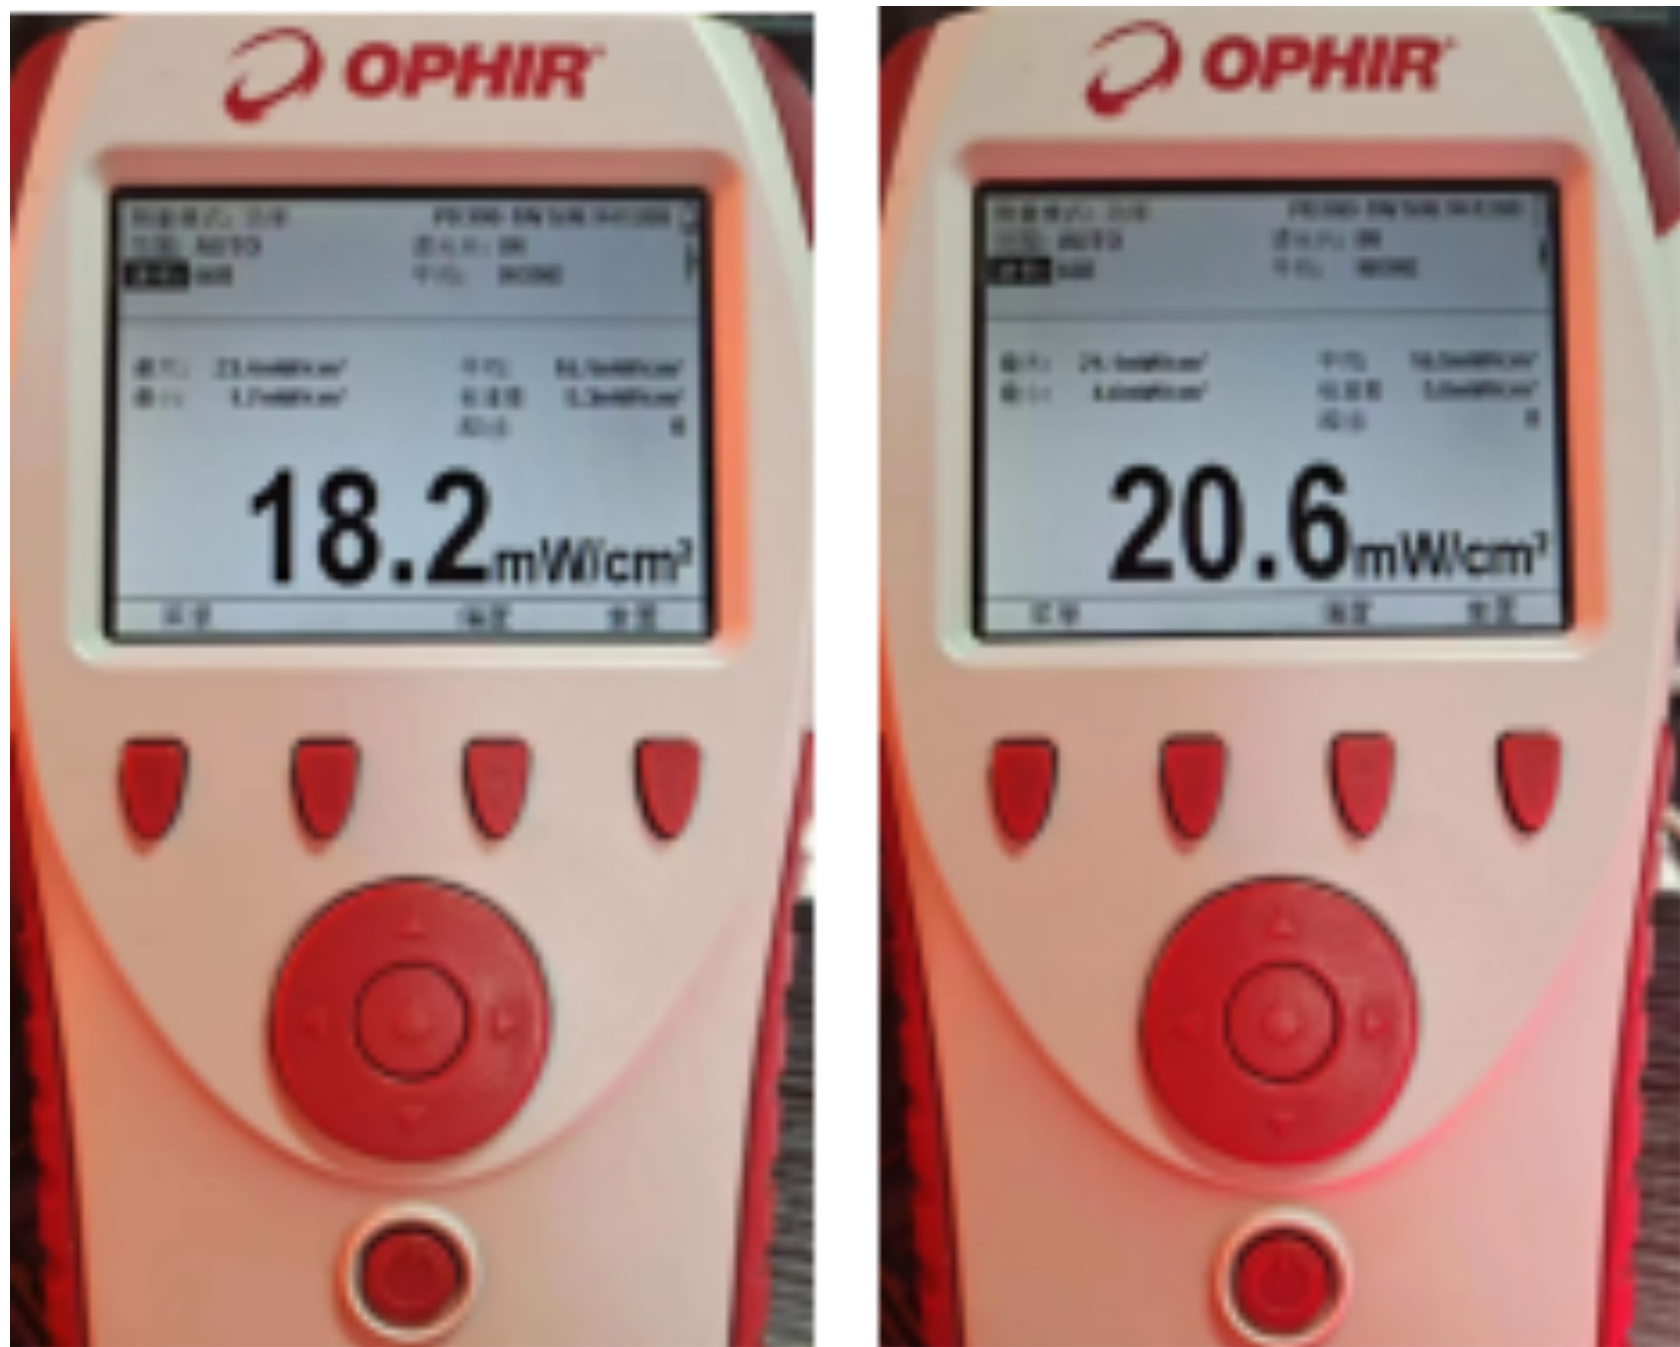
660nm:18.2、 20.6mW/cm²

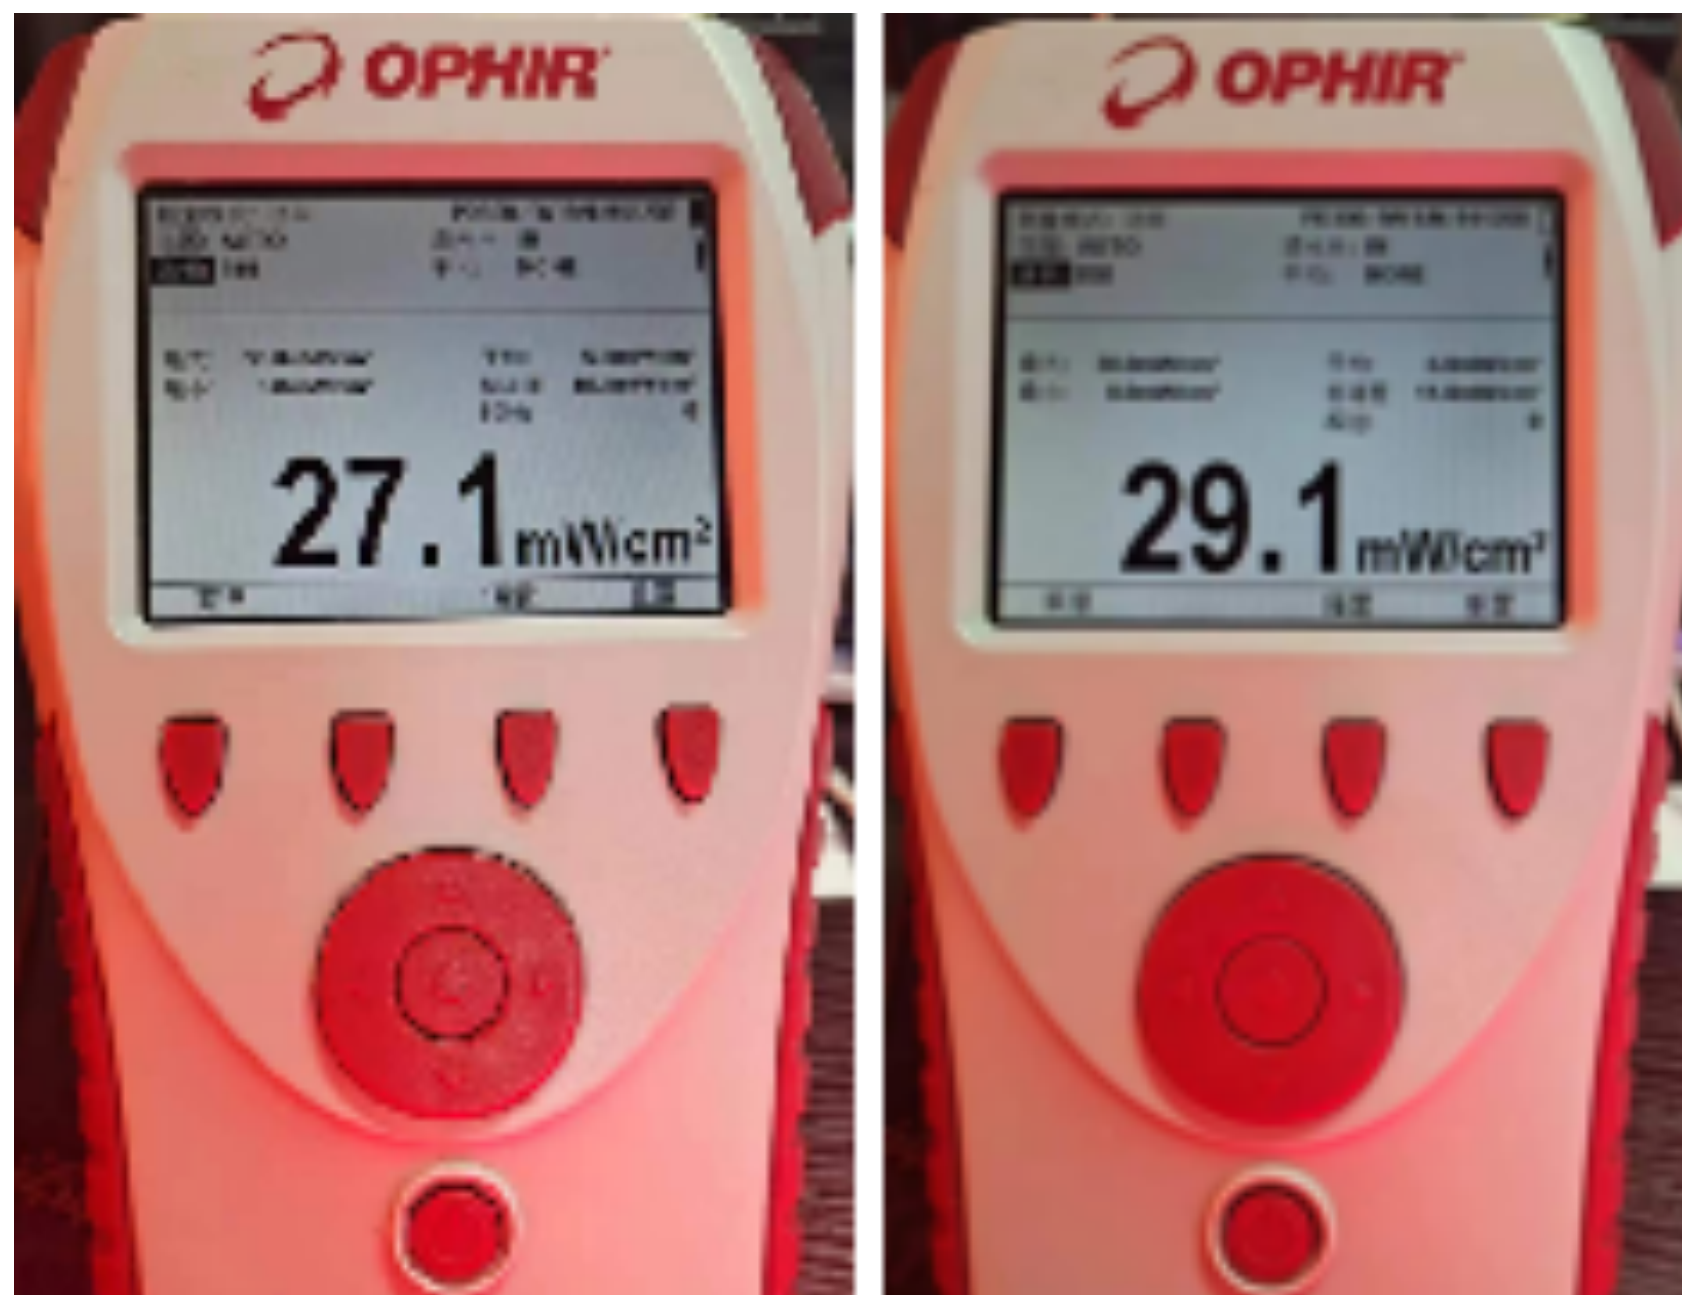
850nm:27.1、 29.1mW/cm²
